**Independent Committee for Extraordinary Advisory on  
Dam Safety  
Final Report  
April 30, 2021**

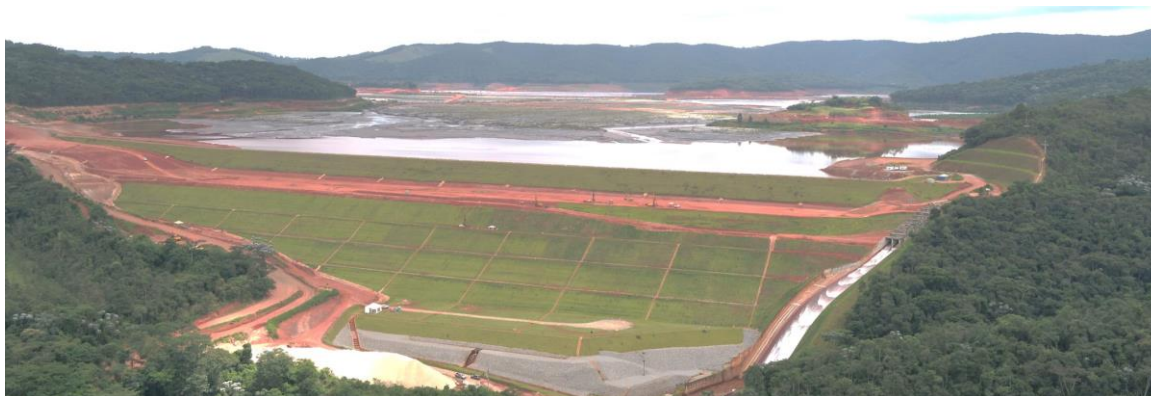
An aerial view of the dam and its tailings reservoir is shown in the figure below. The occurrence of cracks detected in the dam downstream slope was analyzed in the reports mentioned above.

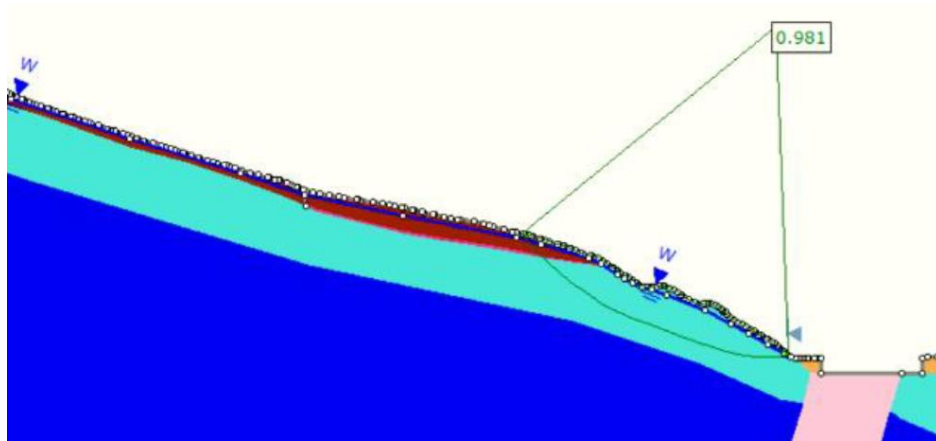
Another concern for this dam is the stability of the right slope downstream of the dam abutment. In addition to evident scars of past instabilities, as shown in the image above, there is a colluvial deposit originated from past slides. In accordance with the stability analyses performed, the slope is only marginally stable, as shown in the following figure. In the stability analysis, the area near the flood spillway channel was assumed to have a factor of safety in a limited state. This instability has the possibility of affecting the channel of the flood spillway.

In the evaluation of the problem, the Committee recommended in November 2020, that before the beginning of the 2020/2021 rainy season, deep horizontal drains (DHDs) should be urgently installed up to the bedrock to lower the water table. After several interactions with the project designer and also of Vale with the Prosecution Office of the Minas Gerais State, the first DHD was installed in February 2021. The installation of inclinometers and water level indicators was also suggested.

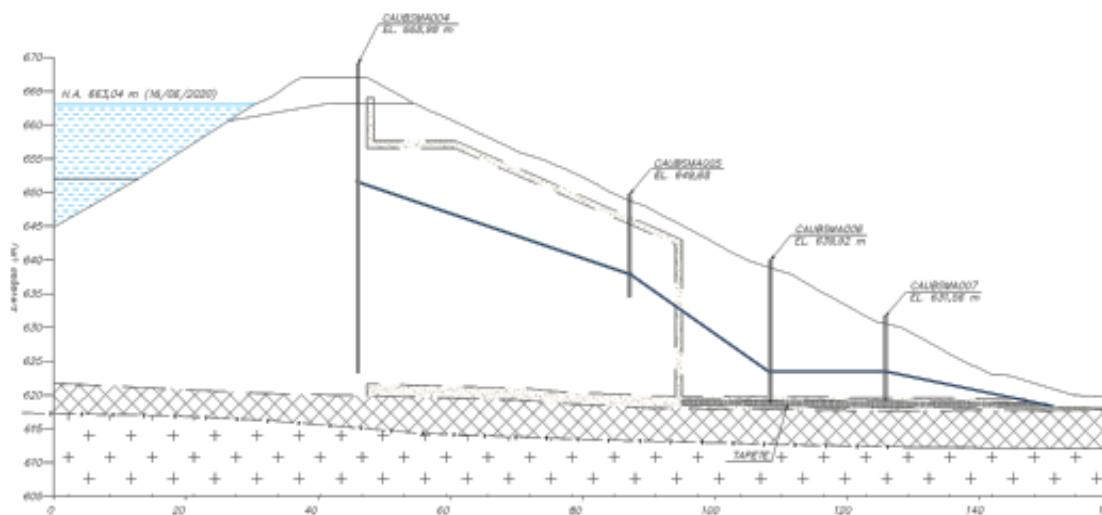
Because the vertical chimney filter was in a very downstream position in the typical cross-section, drainage trenches were excavated in the downstream slope, connecting the first phase chimney filter to the chimney filter of the raised embankment of the second phase.

A typical cross-section shows that the water levels inside the compacted earth embankment are high and indicate poor performance of the first stage chimney filter.

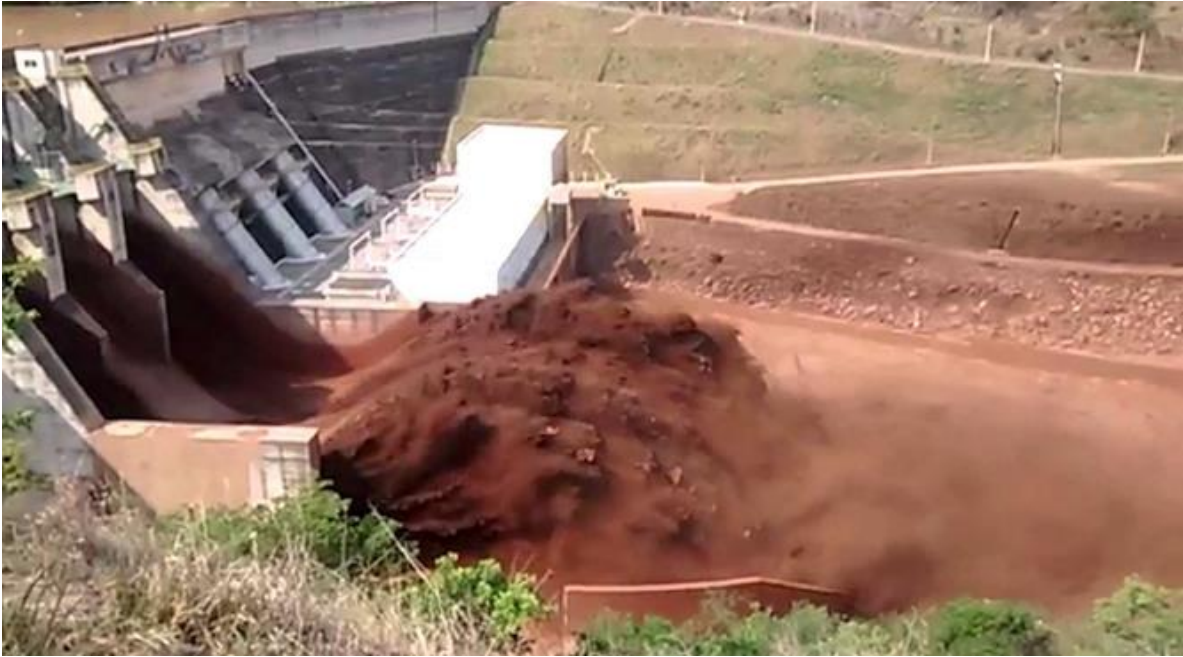
The artificial tailings flood generated by the collapse of the Fundão dam reached the Candonga reservoir at an estimated affluent slurry flow rate of 1,724 m<sup>3</sup>/s that was discharged through two of the three spillway bays of the surface spillway. The central gate was under maintenance, with the stoplog closing the bay. The image below shows the tailings from Fundão being discharged through the two end bays of the Candonga spillway.

During the flood passage, without being able to count on the central gate, the level of the tailings in the reservoir acting on the upstream surface of the dam reached El. 327.47 m, only 0.03m below the reservoir normal maximum water level. The freeboard between the tailings and the dam crest was 2.53 m only. The higher density of iron mining tailings retained in the reservoir at a high level and during a considerable time, the concrete dam structures were exposed to much higher stresses than the design stresses.

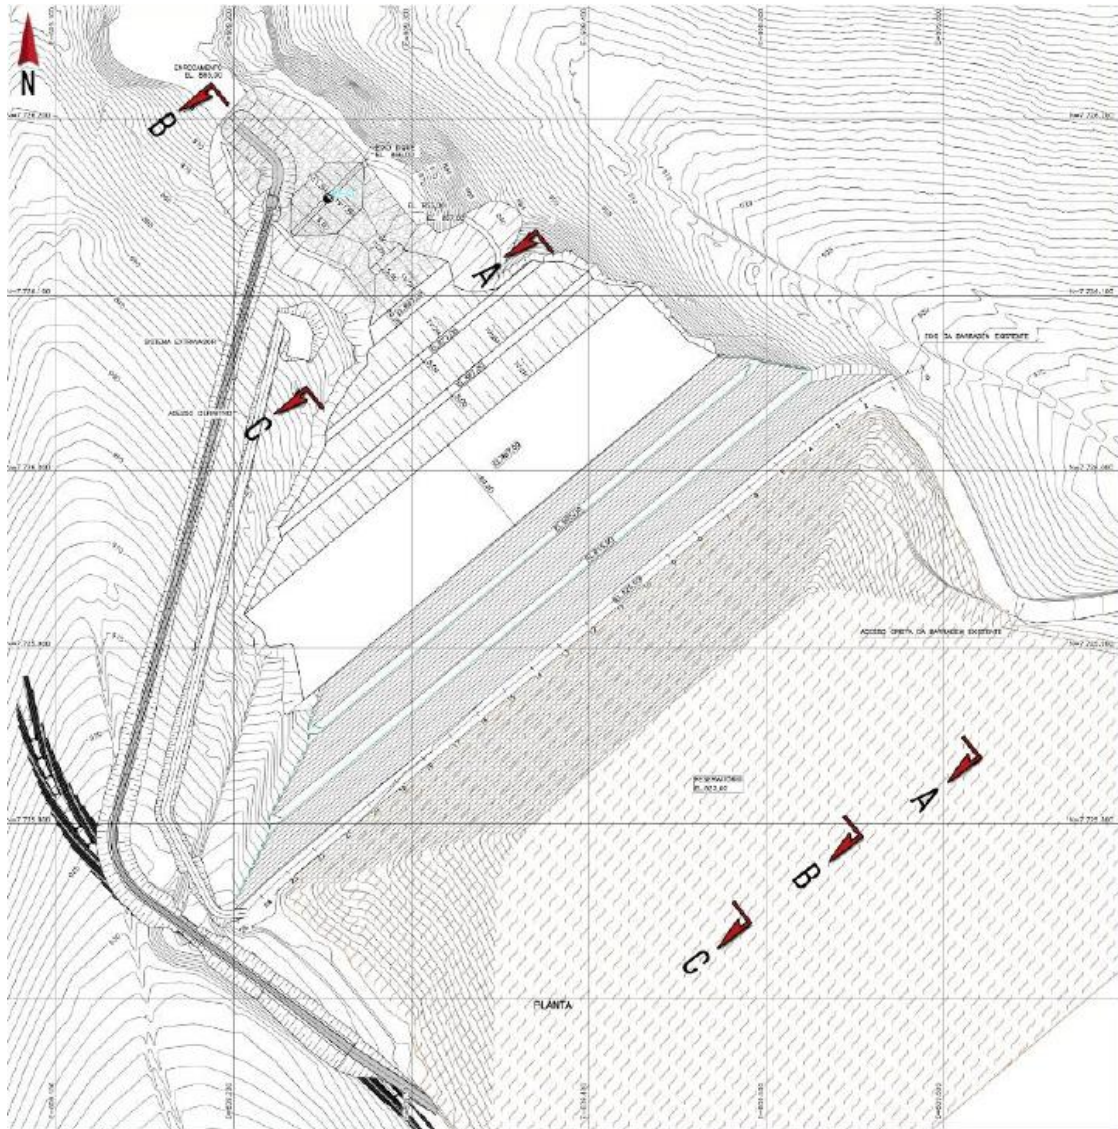
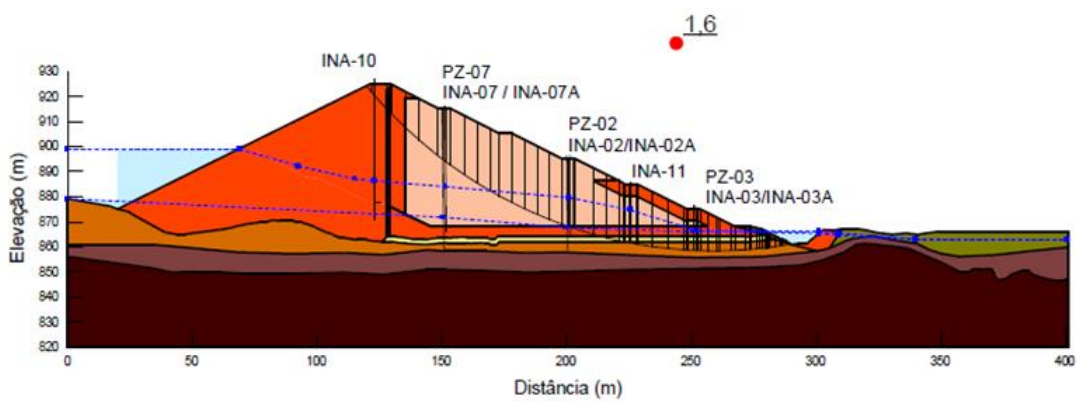
Attention has been drawn to the position of the water table, indicated by the water level indicators (INAs) installed downstream of the dam axis. The water table in the dam apparently ignores the presence of a (supposed) vertical filter, and remains high, even with the reservoir permanently kept at a low level, indicating that there is clogging of the internal drainage system by low permeability soil.

The lack of information about the characteristics of the dam's clayey earthfill and its filters has led the Committee to recommend that the berm, which is not high in the present design, be extended to the reservoir's normal maximum water level and that it should be a drainage transition layer between the current earthfill and the berm. This
