**Independent Committee for Extraordinary Advisory on  
Dam Safety  
Final Report  
April 30, 2021**

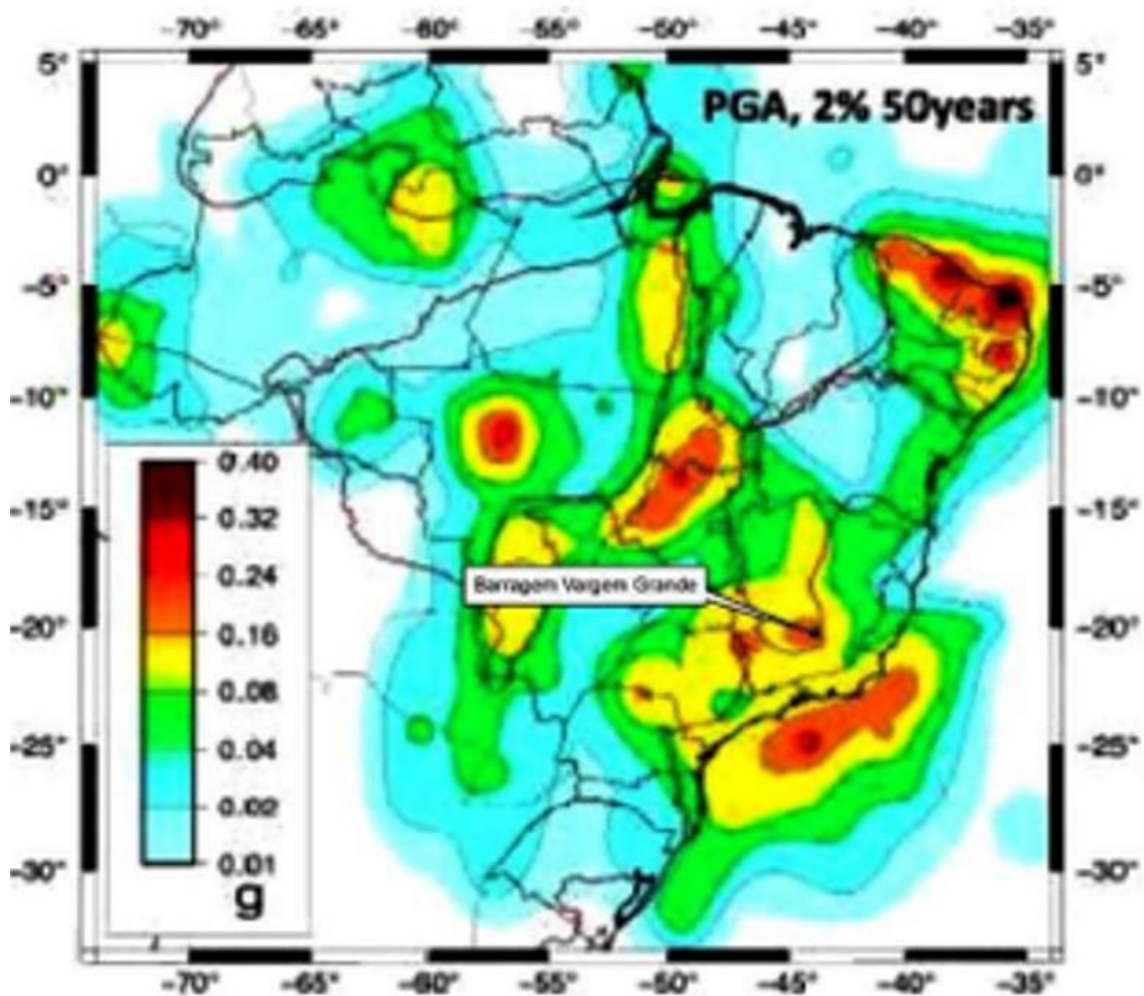
**Map of Seismic Hazard in Brazil. Peak Acceleration.**

Fig. 7b presents zoning for areas with a probability of exceedance of 2% in 50 years, which corresponds to the return period of 2,475 years. The design firm DF+ presented the location of the Vargem Grande dam on the map of Fig. 7b, reproduced below.

**2% probability of exceedance in 50 years, which corresponds to a return period of 2,475 years. Indicating the location of the unit.**

It is recommended that Vale urgently arrange for a qualified study of seismic risks in the Iron Quadrangle region of Minas Gerais State and decide at a high hierarchical level (decision of a technical and managerial nature) which return period should be adopted for each dam project in the Iron Quadrangle region. It is worth noting that currently international best practices for dam design recommends that the selection of the design seismic event return period should be a function of the consequences of a hypothetical dam collapse. The consequences of a collapse are influenced, among other parameters, by the number of people at risk and those who could be affected by environmental and cultural impacts, and the costs of repairing the area affected by the collapse.

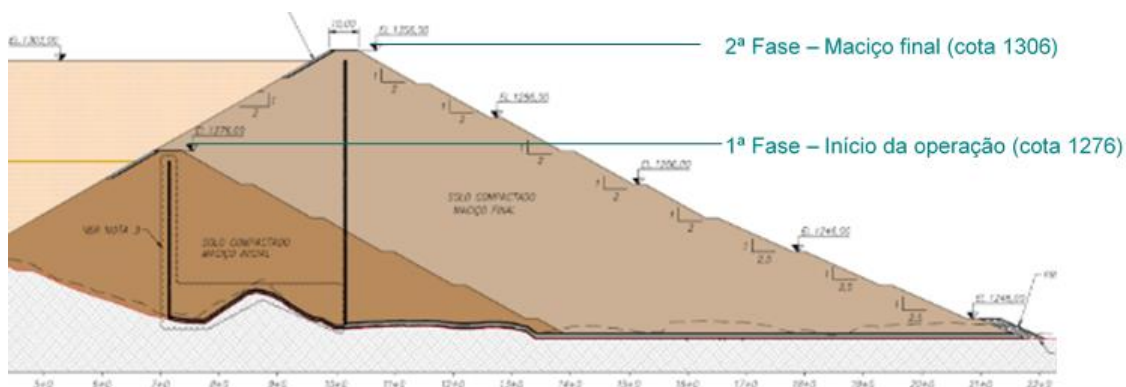
It was necessary to construct a blanket of low permeability soil to cover a permeable quartzite outcrop. The following figure shows the main dam section, including the raise and with the internal drainage system highlighted.

The Committee has visited this dam since the early months of 2019 and issued several reports on different aspects of the design and construction. The first comment was about the positioning of the vertical filter. The upper portion of the filter was located at the dam axis, very close to the reservoir. The displacement of the filter to downstream in the design documents was recommended.

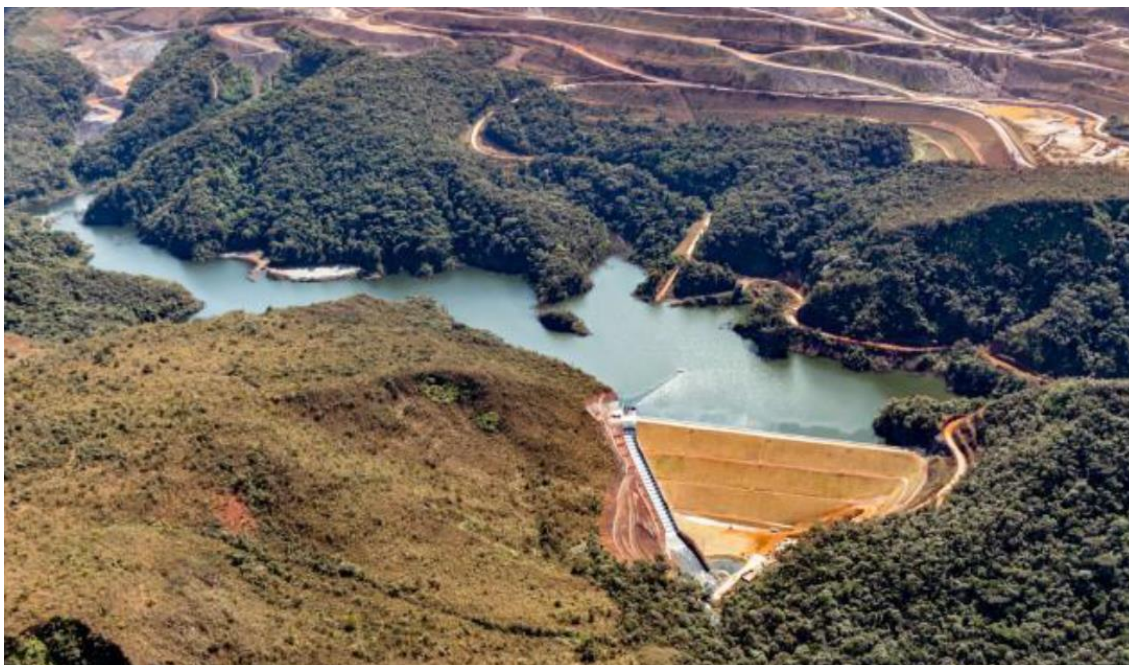
Another concern for this dam is the stability of the right slope downstream of the dam abutment. In addition to evident scars of past instabilities, as shown in the image above, there is a colluvial deposit originated from past slides. In accordance with the stability analyses performed, the slope is only marginally stable, as shown in the following figure. In the stability analysis, the area near the flood spillway channel was assumed to have a factor of safety in a limited state. This instability has the possibility of affecting the channel of the flood spillway.

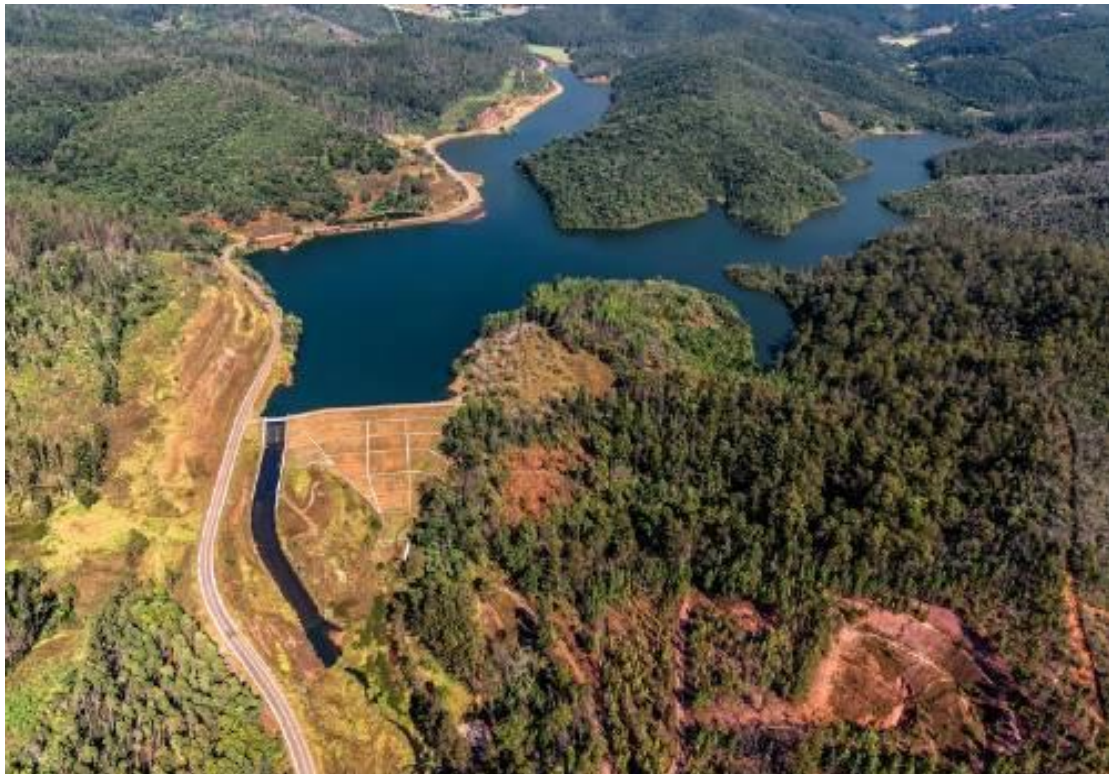
The Santana dam deployed in the Jirau stream is part of the Itabira mining complex, Cauê Mine, in the municipality of Itabira, MG. The dam is of rolled zoned soil cross-section type, founded on gneiss saprolite and an altered rock mass, with relatively steep slopes near the crest in the raised portion, from 1V:1.85H upstream and 1V:1.5H downstream.

Because the vertical chimney filter was in a very downstream position in the typical cross-section, drainage trenches were excavated in the downstream slope, connecting the first phase chimney filter to the chimney filter of the raised embankment of the second phase.

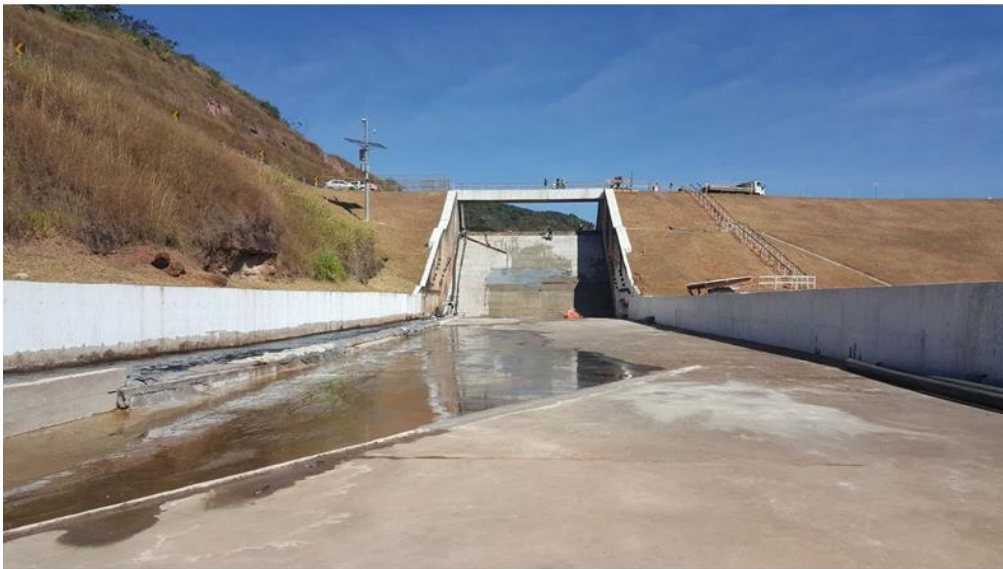
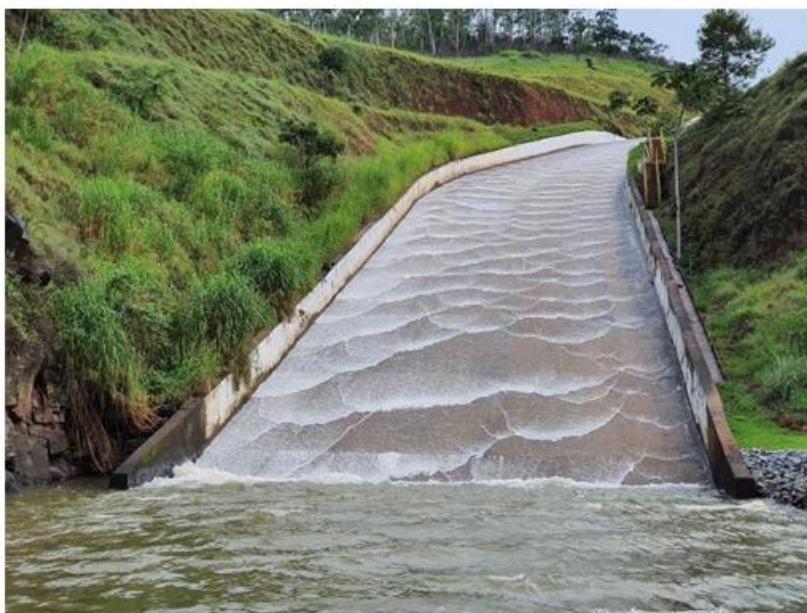
The flood spillway system consists of a free-surface spillway constructed in the right abutment. The channel has variable slopes, 2 m side walls in concrete and follows a curve to the hydraulic left in its middle portion before discharging into a dissipation basin. The current spillway crest was constructed on the original crest designed in 1977, and that resulted in a very steep spillway apron that increased the water flow speed. The figure below shows the spillway ogge and the initial part of the channel.

The hydrological evaluation of dam overtopping performed by the Committee resulted in full dam safety in the most unfavorable scenarios possible. However, the spillway system's hydraulic performance must be verified because, for the occurrence of design extreme discharges between 200 m<sup>3</sup>/s and 300 m<sup>3</sup>/s, there may be overtopping of the spillway channel downstream of the spillway ogge due to the potential formation of a hydraulic jump and certainly in the curved section with high gradient (34.36%) in which there is no superelevation of the channel or a deflector high wall to avoid overtopping. The recommendations of the Committee will be adopted.

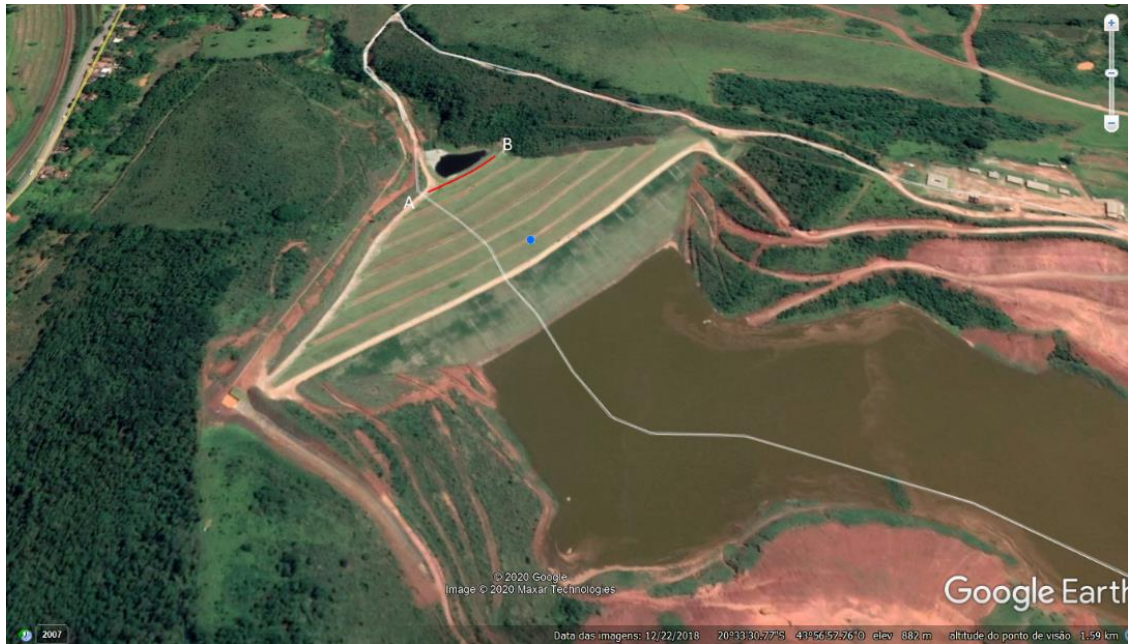
The structure is a 64-m high rolled earth dam, constructed in a single stage, to retain the tailings from the Viga Mine, located in the municipality of Joceaba, MG. Originally, the dam was to be raised by downstream to increase its tailings storage capacity. The crest of the dam is at elevation 925 m. The design of a downstream stabilization berm is ongoing, to a maximum elevation of 897 m.

Attention has been drawn to the position of the water table, indicated by the water level indicators (INAs) installed downstream of the dam axis. The water table in the dam apparently ignores the presence of a (supposed) vertical filter, and remains high, even with the reservoir permanently kept at a low level, indicating that there is clogging of the internal drainage system by low permeability soil.

The lack of information about the characteristics of the dam's clayey earthfill and its filters has led the Committee to recommend that the berm, which is not high in the present design, be extended to the reservoir's normal maximum water level and that it should be a drainage transition layer between the current earthfill and the berm. This

transition will ensure that the internal drainage maintains the saturation line inside the embankment with or without the occurrence of cracks by differential settlement of the current dam compacted embankment. In addition, the installation of a line of relief wells located downstream of the inoperative chimney filter should be studied. These relief wells must pass through the drainage blanket and reach the foundation ground.

The design considers an excavation up to 12 m deep in the region just downstream of the existing dam toe. The existing alluvium in this area is inadequate as a foundation for a berm more than 20-m high. For this reason, the design indicates the need to remove this low strength soil before the reinforcement berm earthfill is constructed.

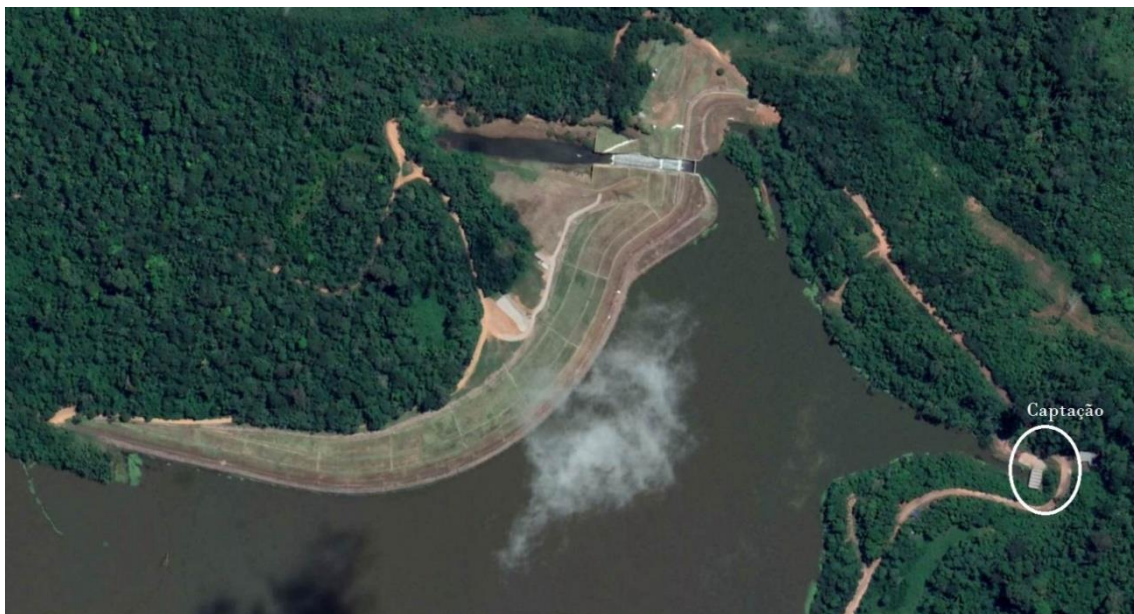
The Gelado dam, located in the North Corridor, in Carajás, serves to contain tailings and sediments, in addition to water storage. The dam was constructed in three stages, consisting of a starter dam of compacted soil and two downstream raises also of compacted soil. Both the starter dam and the two raises had internal drainage consisting of chimney filters and sub-horizontal drainage blankets. However, in all three phases of construction, the drainage blanket was constructed on a thick layer of compacted soil that filled the excavation of the surface soil at the dam site. This backfill had thicknesses from 2 m to 12 m and prevents the contact of the blanket to the foundation soil, wrapping the blanket and preventing it from being a foundation drainage element (same detail as the B-7 dam design). In the design, at all phases and by different project designers, the function of the blanket is only to transport the water captured by the chimney filter to downstream, without relieving the foundation interstitial pressures.

In 2018, before the "as is" design definitions, the estimate of the factor of safety was 1.81 for normal operation condition without seismic events. After the completion of the "as is" definitions, with less optimism as to the basic data, the factor of safety for the highest cross-section was 1.5 for normal operating conditions and 1.41 for the scenario of the inflow of the spillway design discharge. For the condition of occurrence of a seismic event, the factor of safety obtained was 1.28. Although the factors of safety obtained were reasonable, considering the insufficient saturation of the samples submitted to triaxial tests, the Committee recommended expanding the testing campaign and performing subsequent stability calculations.

The investigations completed to define the "as is" characteristics determined that there are three different types of typical cross-sections in the dam, without delimiting transitions locations between these segments. Considering the indicated uncertainties, the Committee recommended a reinforcement study to increase the theoretical factor of safety of the dam to 2.

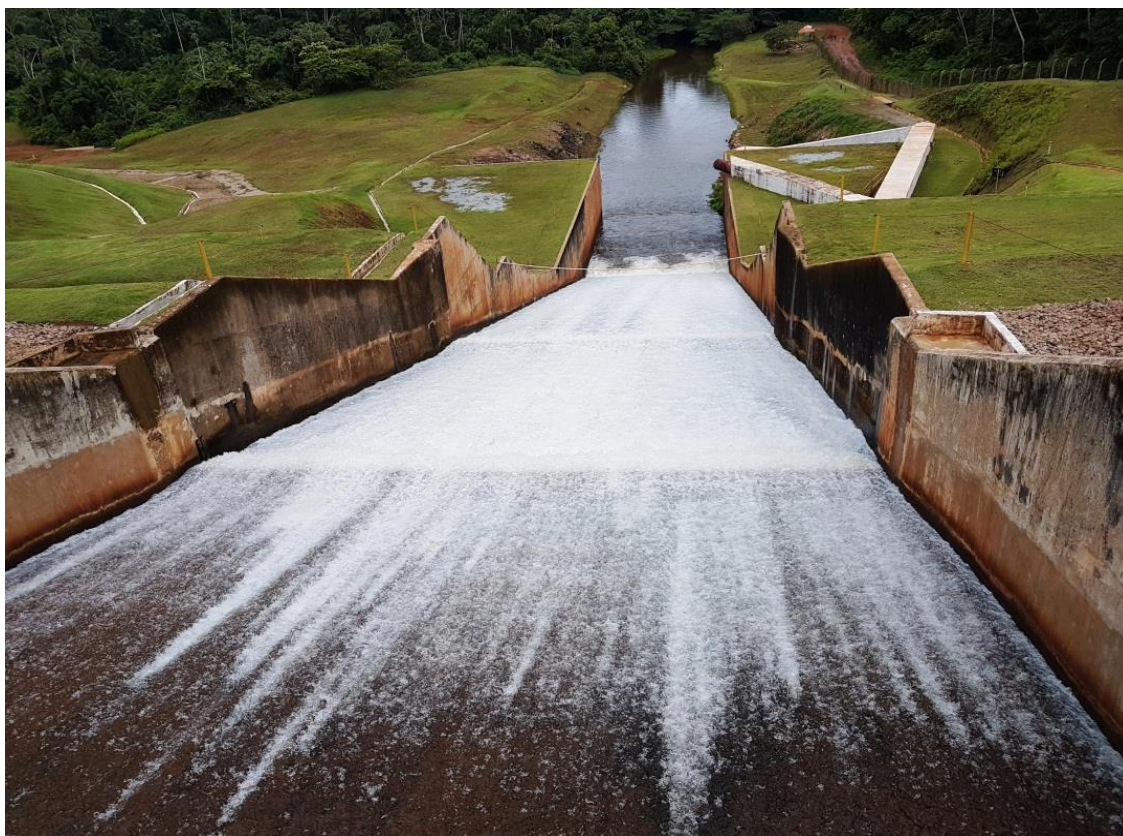
The flood spillway is an uncontrolled surface spillway, in concrete, 15-m wide and with a sill discharging into a concrete apron with aeration elements. The Committee recommended concrete repair works, which were reported to have been completed recently.

The Committee calculated the transit of the 1,000-year flood flow in the reservoir, that resulted in a comfortable freeboard of 1.5m. If the dam is not raised in the short term, a review of the 1,000-year flood flow transit study is recommended and the transit of the 10,000-year flood flow is recommended to be adopted.

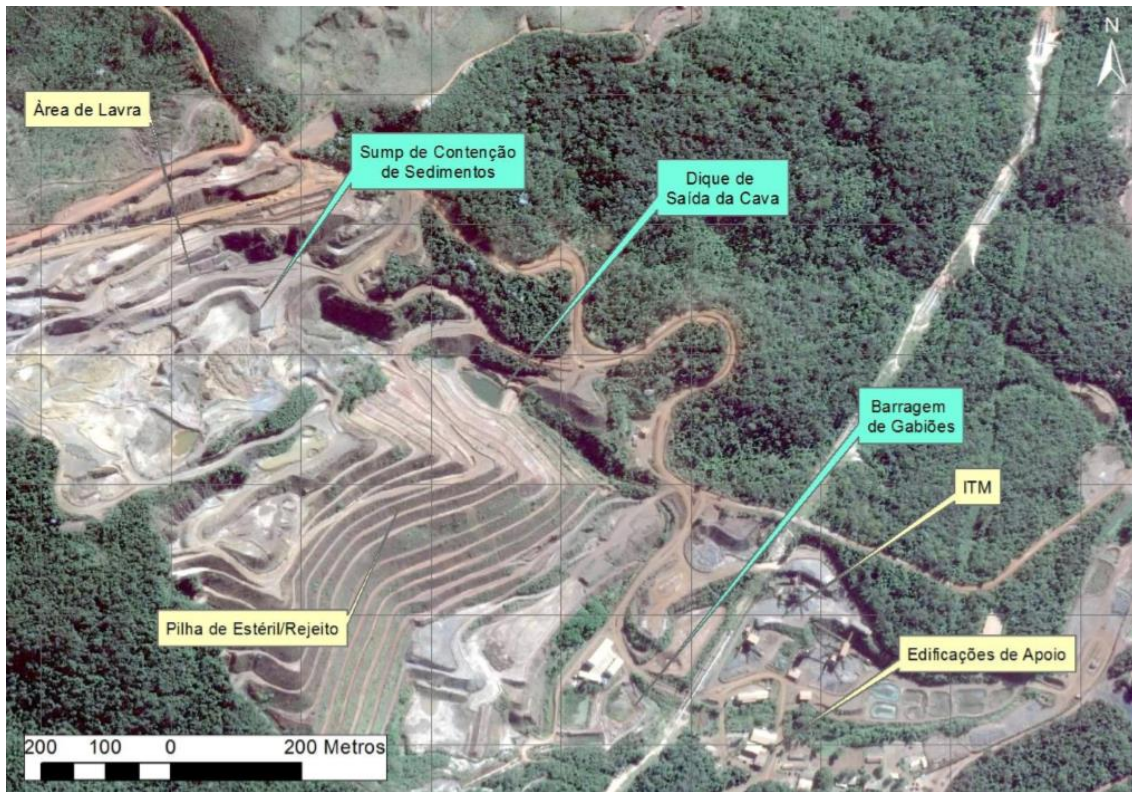
This pile shown in the following image, is 125-m high, and was constructed on a slope, with tailings and waste rock from the Esperança Mine, subject of a recent acquisition by Vale from Ferrous.

The Esperança Mine is located in the municipality of Brumadinho and its main structure is a pile of waste and tailings from the Esperança Mine itself and from the Santanense Mine. The pile basically consists of waste wrapping pockets of tailings inside (waste and tailings pile - PDER).

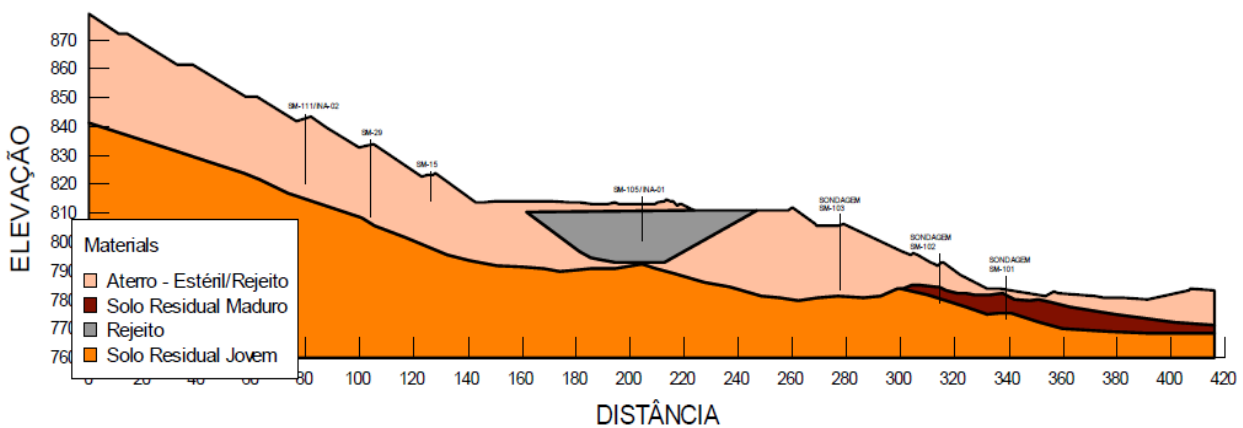
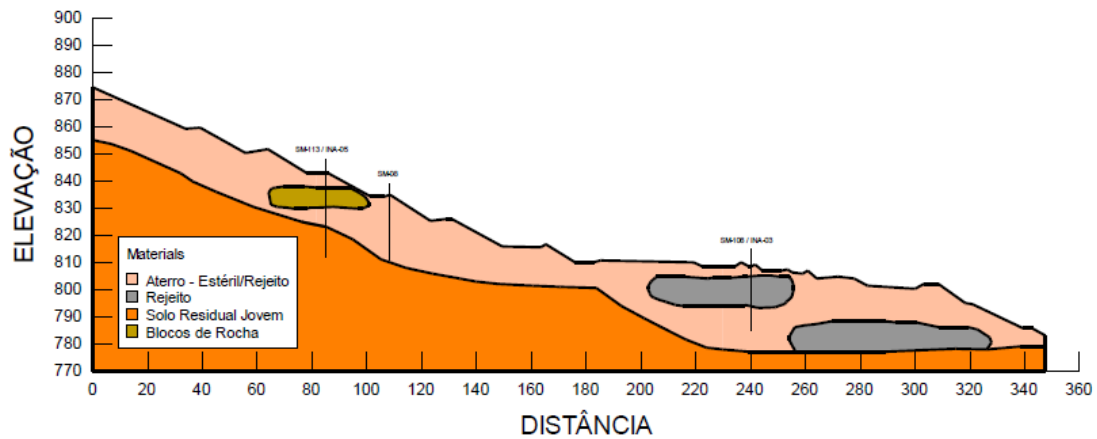
The figures below show the representative pile cross-sections, with low strength and high compressibility tailings pockets identified during drilling that was recently performed.

This pile was implemented against a natural hillside slope and was raised upstream. In this pile, there is a small sediment containment of about 9-m high at a high elevation, an 8-m high outlet dike on the left side and a 5-m high gabion wall at a lower elevation.

As the pile contains heterogeneous materials (tailings and waste), and as the characteristics and positioning of these materials, their compositions and densities were not accurately known, and the positioning of the water table for wet periods was not known, the factor of safety of 1.37 estimated at the time, had a considerable level of uncertainty.

This treatment was recently completed. In March 2021, the designer reported the evolution of the factors of safety of four cross-sections analyzed. The factor of safety for drained analyses increased from the minimum value in 2019, under the conditions in which Vale took over the pile, from 1.4 to 1.55 after treatment. For undrained analyses, the factor of safety increased from 1.0 under 2019 conditions to 1.30 after treatment in 2021. It is recommended that the pile reconfiguration design be carried out.

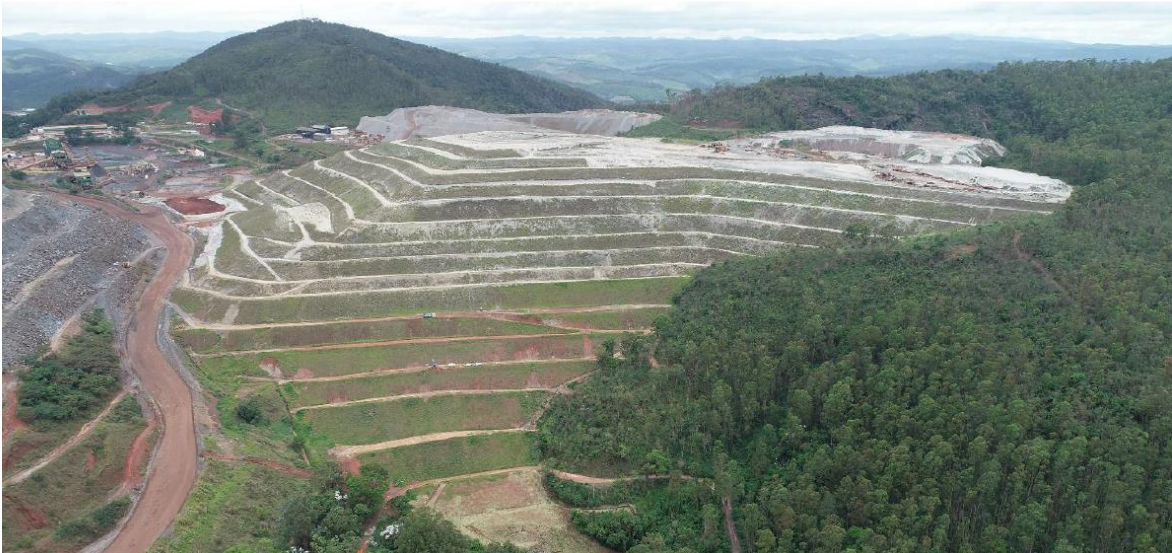
The drained pile has an accumulated volume of  $19 \times 10^6 \text{ m}^3$ , has a height of 145 m, with 6-m wide berms every 10 m in height, forming an overall slope of 1V:2.7H. An aerial view of the pile is shown below.

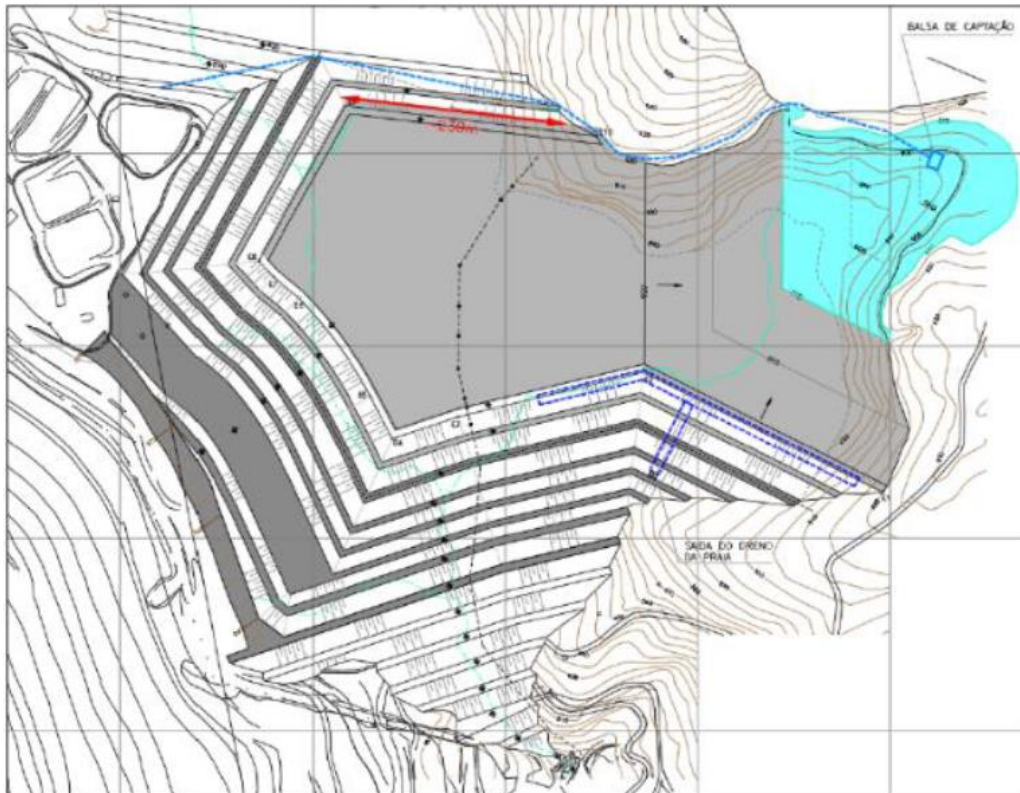
The drained pile has three free slopes and in the rest of the area the stack rests on the local elevations. The figure below shows a plan view of the pile, with its shape of an irregular polygon. The external slopes are vegetated and have an efficient surface drainage.

The structure has instrumentation consisting of 7 piezometers, 13 water level indicators (INAs), a flow meter, 22 monitoring prisms, 6 control prisms, and 2 prism monitoring

bases. In addition to this terrestrial monitoring, INSAR satellite monitoring is also performed. The instrumentation installed in the structure is fully adequate and well operated. The phreatic surface is low, which confirms the efficiency of the internal drainage system. Satellite monitoring has shown no movement of the slopes.

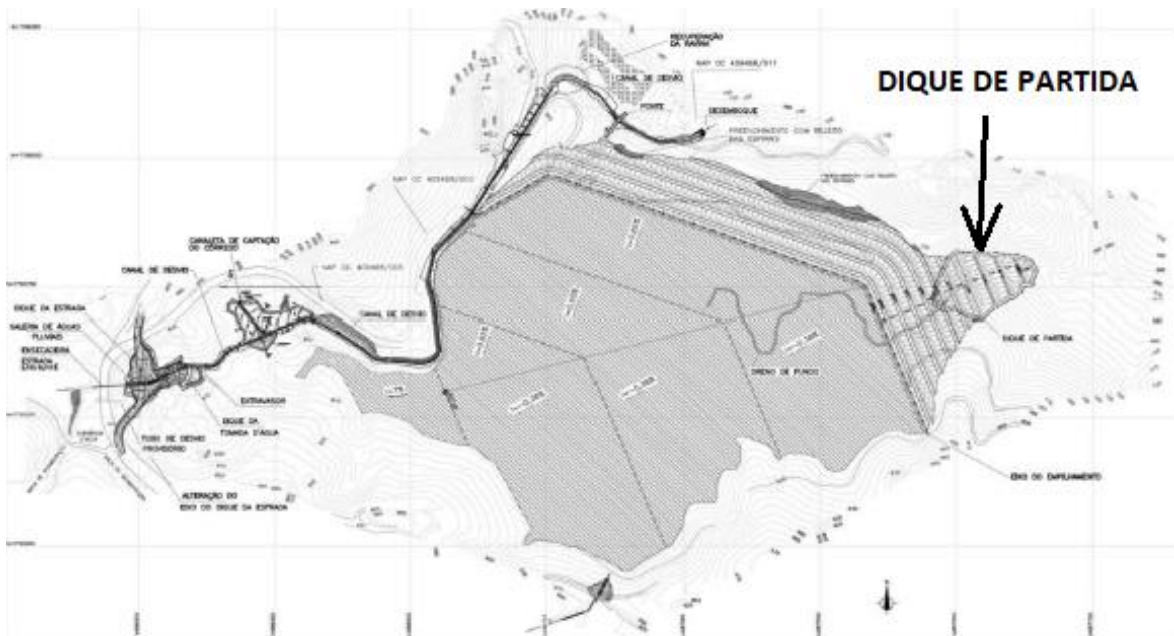
The pile was originally designed to operate until 2021 and reach El. 810 m. The following figure shows the pile as designed.

Monitoring is performed by 11 piezometers, 9 water level indicators (INA's), 13 monitoring prisms and a flow meter. The instrumentation installed in the structure is fully adequate and well operated. The instrumentation indicates well controlled and very low water levels, which confirms the efficiency of the internal drainage system. Satellite monitoring was initiated and shows no movement of the slopes.

The phreatic surface is low, leading to satisfactory values of factors of safety for all scenarios. The table below indicates the results of static and pseudo static stability analyses, which meet all the requirements stipulated by ANM.
